## Stove Testing in Tajikistan – December 2015

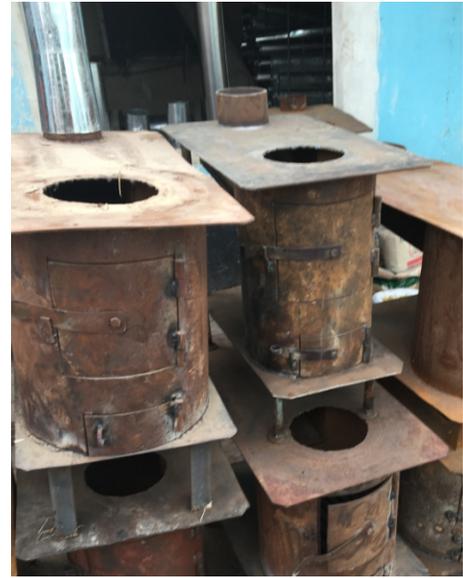
In the living room where the family spends quite a lot of time, there was the 'main stove'. It was locally made (artisanal) from thick, scrap pipe from the district water heating system. It is connected to a vertical chimney about 1.8 metres high which connects by an elbow to a 7 metre long horizontal chimney leading out of the house. There is no vertical portion after that – the exit is horizontal.

Figure 1: The locally made stove with the long horizontal chimney tested with wood and then coal.

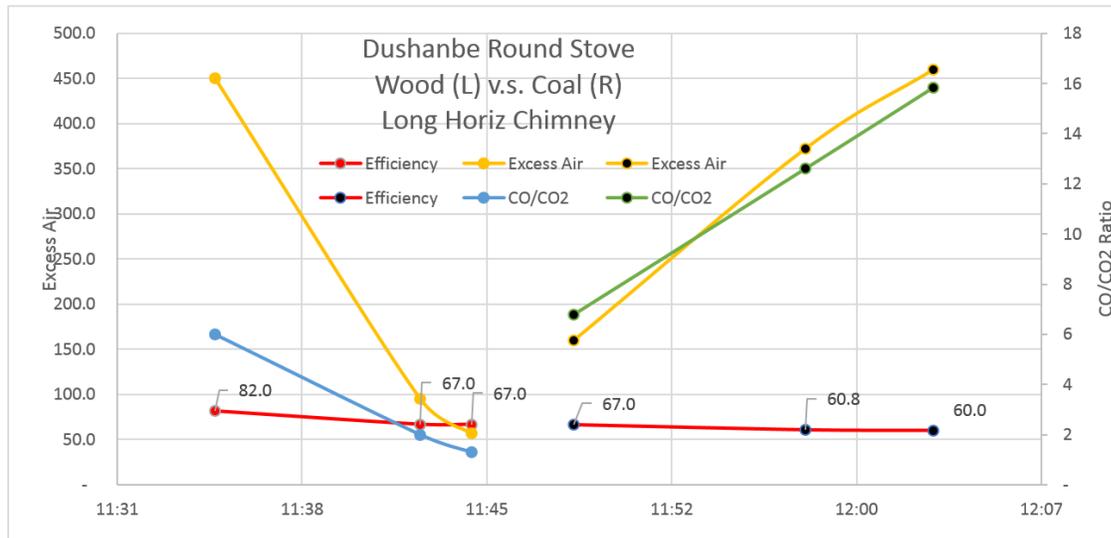
As expected, the efficiency when the stove was cold is very high because there is little heat from the fire leaving the home. After ten minutes it settles down to about 67% efficient when fuelled with wood. As can be seen on the left set of lines, the CO/CO<sub>2</sub> ratio (blue) drops rapidly as the excess air ratio (yellow) drops. This indicates that there is too much air getting into the stove. There was no opening to the fire chamber – all the air getting into the stack comes from below the grate. As the fire grew in intensity and used more of the air, the excess air volume (not needed for combustion) dropped from >400% to less than 60% which is dangerously low. Even when the air was in short supply, and the exit temperature was a modest 131°C, the efficiency was no higher than 67%. This indicates the heat exchanger area was

not large enough, even with a very long chimney. The burn rate increased, using the available oxygen, but the stove could not deliver the heat into the room.

We then switched to coal by adding about 1.5 kg to the fire. The immediate response was for the CO/CO<sub>2</sub> ratio to jump up to 6.8%. As the flaming pyrolysis stage started, the stack temperature started to drop. This would normally indicate an increase in efficiency however as the burn progressed, the volatiles burned out and the excess air climbed. In that condition the efficiency drops. The combustion efficiency, using the proxy of the CO/CO<sub>2</sub> ratio, rose higher and higher as the combustion conditions deteriorated. There is a strong correlation between the CO/CO<sub>2</sub> ratio (green with black markers) and the level of excess air (yellow with black markers). The cause is the chilling of the fire. The coal cannot burn at the same rate as the wood. As the heat dies down, the excess air overwhelms the benefit of a higher heat density in the fuel. The result is a drop in efficiency, in spite of the long chimney pipe.

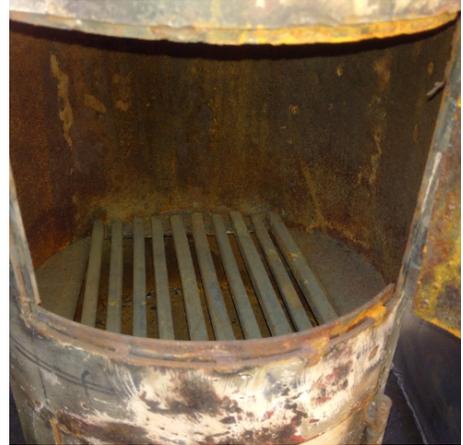
Figure 2: The same stove as the one in the house, tested with a standard 4.2 metre chimney.

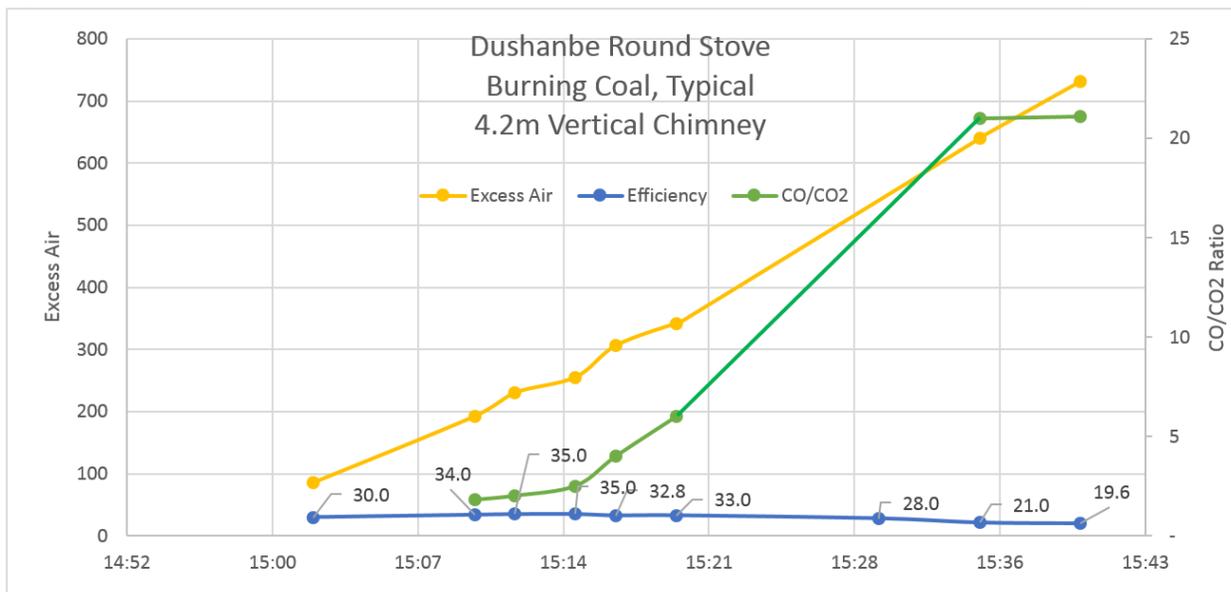
The first noticeable number is the very low heating efficiency: 30%. As the fire developed it rose to 35% and then, as can be seen with the yellow line, the excess air rose continuously. After about 15 minutes the CO/CO<sub>2</sub> ratio rose above 3%, the losses from CO started to jump. The rapid rise at 15:14 is a combination of cooling excess air and the increased loss of energy in the form of CO. The fire was then set into "night time mode". The efficiency continued to drop settling at less than 20%. The major reason was high excess air leaking into the stove through all joints. There is no combustion chamber per se, just an open space. The burn rate in such a stove is very low and it doesn't take much leakage to take the heat outside.
